Due-Diligence of a Small Hydropower Plant

Case Study Peru HPP

Training Workshop “EBRD: Financing Small Hydropower Plants in Ukraine”

Kiev, 05.10.2011

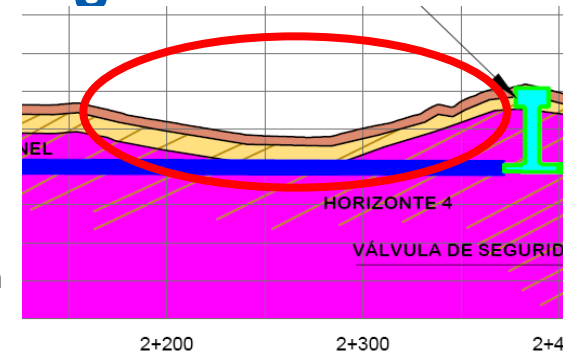
Surge Tank

- Drillings have been executed at the surge tank location, up to a depth of approximately 50 m below natural field.
- Results from the drilling show that the hill where the surge tank is planned is constituted by the previously mentioned sedimentary conglomerate.

- The upper part of the conglomerate shows low fragmentation with RQD values around 80%. The quality of the rock decreases in depth where the samples show RQD values between 0% and 30%.

- At the end of the drilling, the quality of the rock increases again.
- Possible explanation for this outcome is the presence of a fault near the hill, which may have shifted resulting on a shear zone.

- The fragmentation and shearing of the rock will complicate the excavation of the surge tank.
- Measures to stabilize the rock surrounding the surge tank could become necessary.

- It is highly recommended to further analyse the activity of the fault, in order to exclude potential future activity

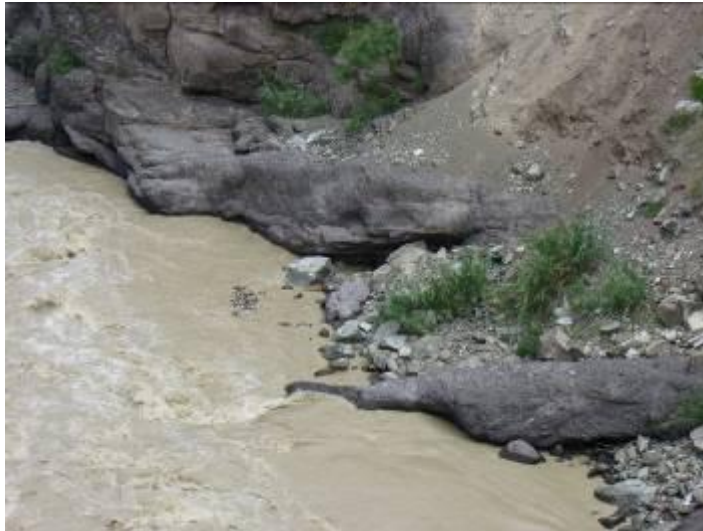
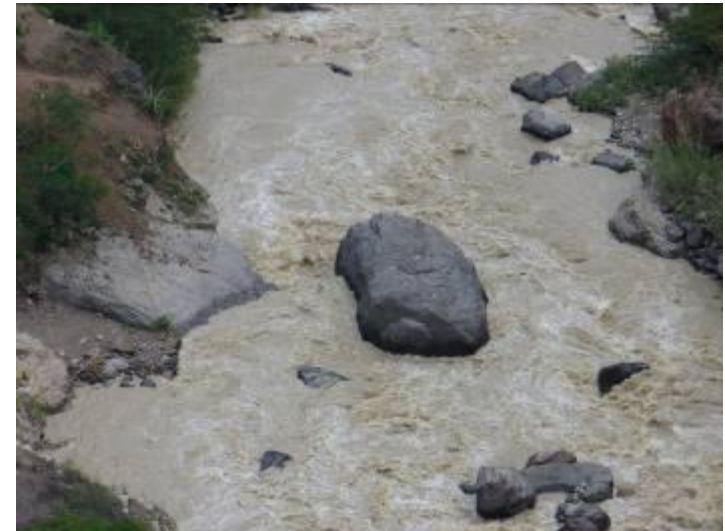
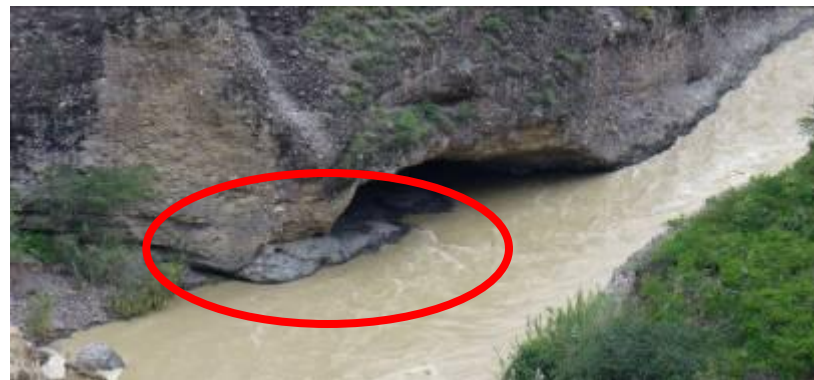
Outcrops in River Bed

- Along the river, outcrops of very competent rock are visualized close to the river bed

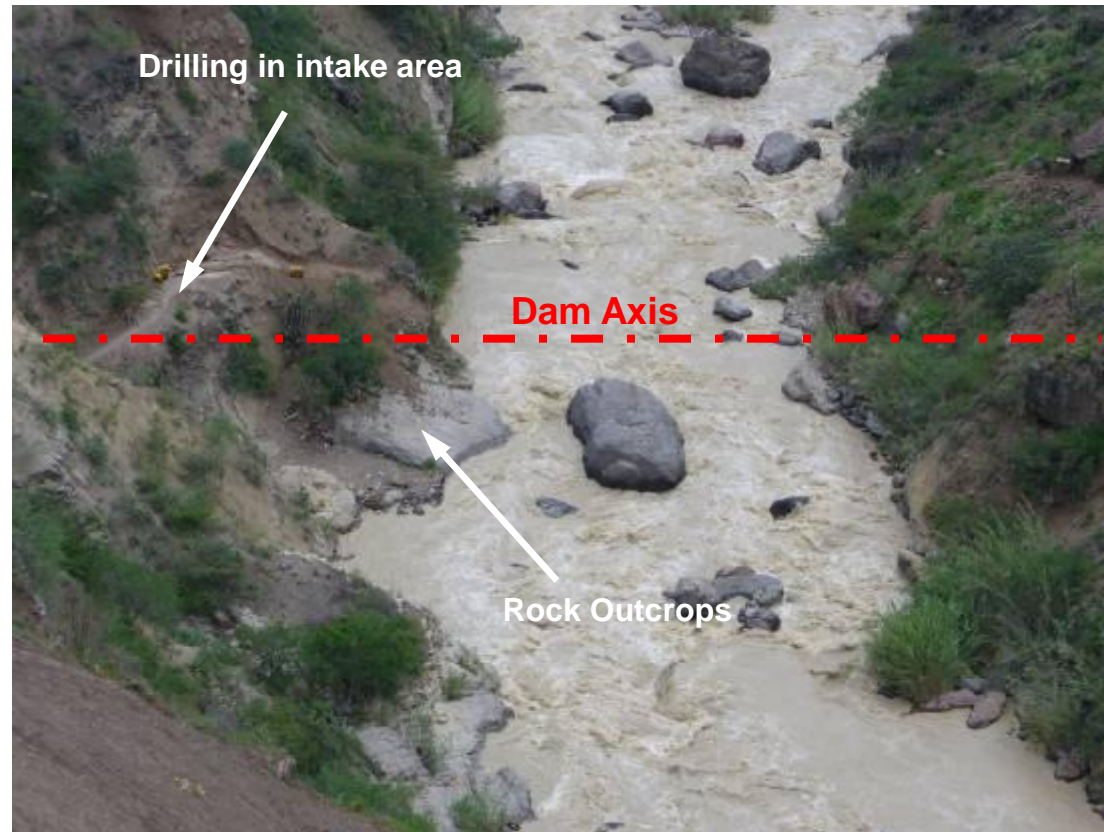
Dam and Intake Area

- According to boreholes carried out on both sides of the river, there seem to be competent rock in the location of the dam and intake.

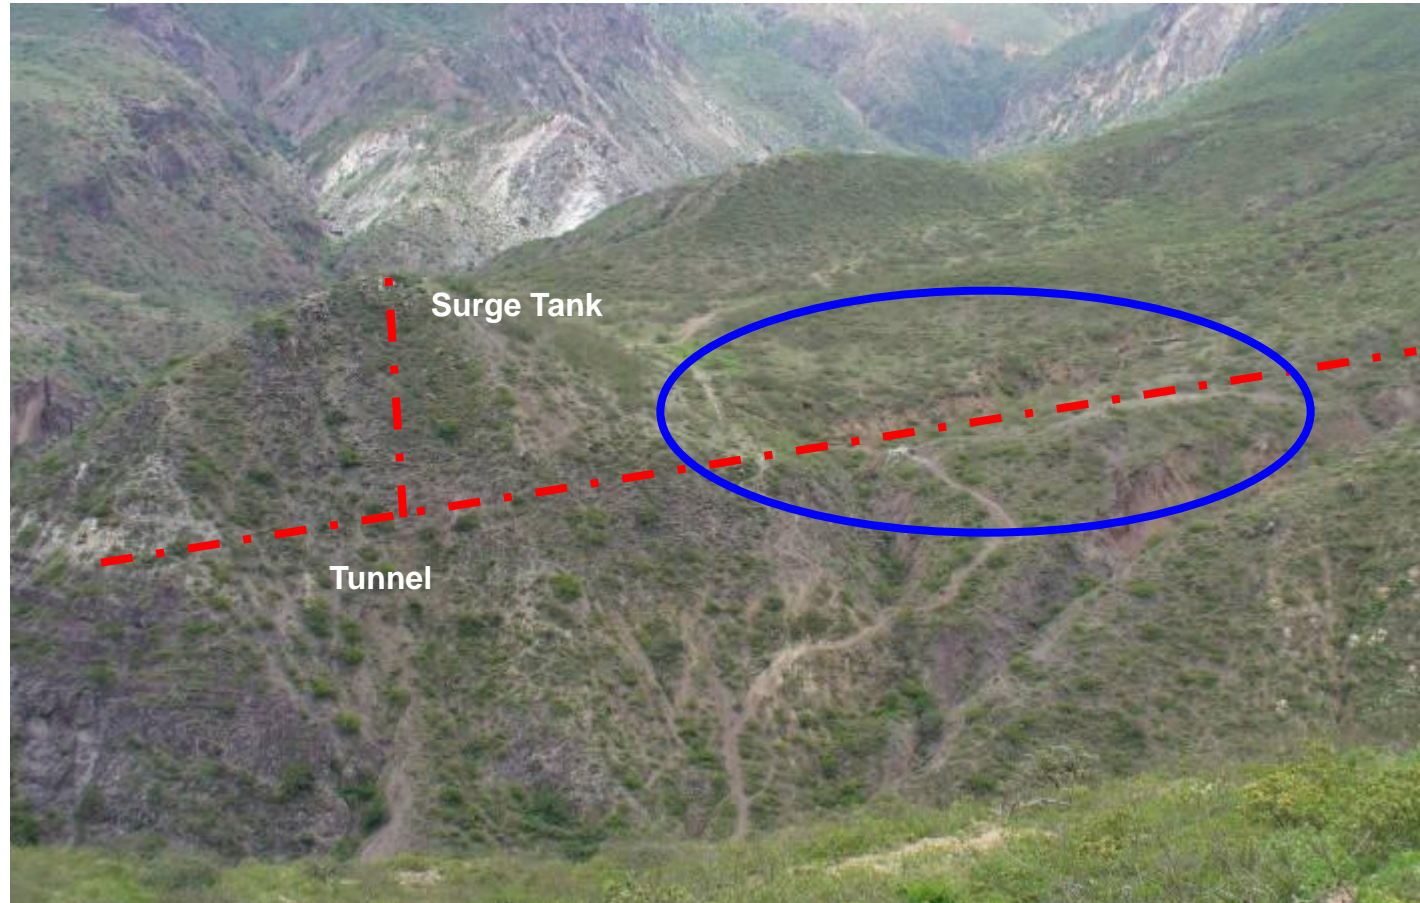
- Right upstream of the surge tank, the topography shows a depression that leaves the tunnel with little covering (approx. 15 m). The boreholes in that zone show presence in depth of highly weathered soil-like material.

- View of the topographical Depression, upstream of Surge Tank

- It is recommended to further investigate that area and evaluate modifications to the tunnel design.
- **A Consultant** has already commenced some evaluation of possible alternatives to overcome this problem.

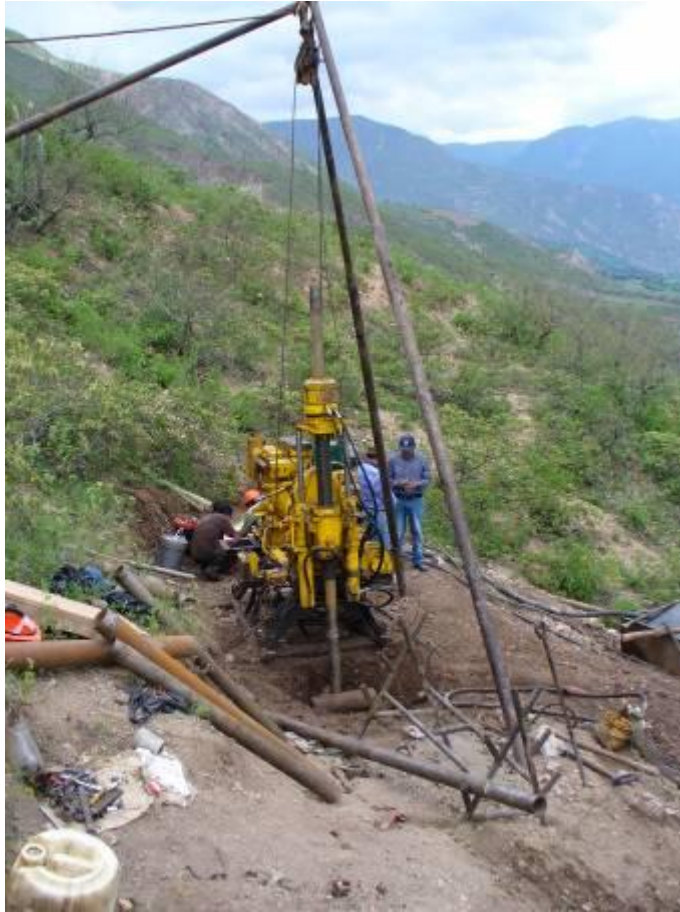
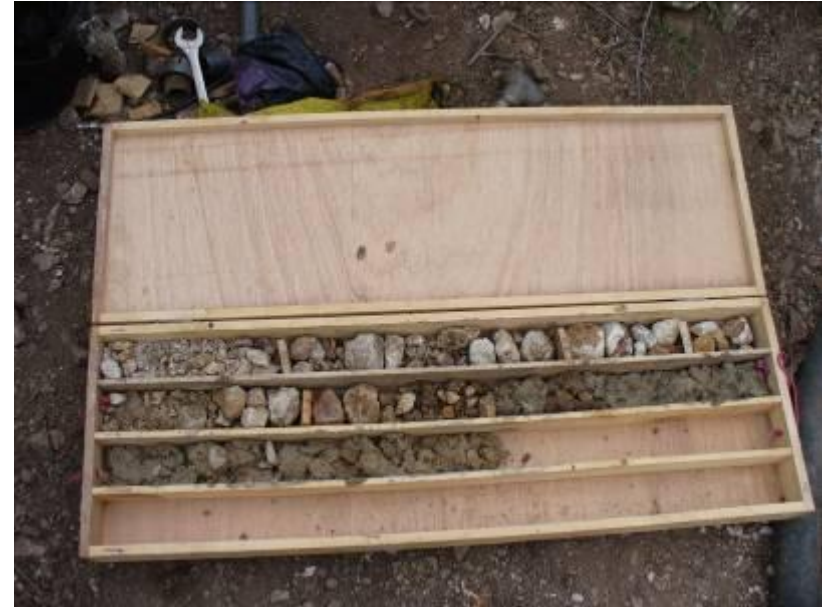
Drilling at Powerhouse Location

- View of the drilling rigs and the samples on the Power House location

- Cutting samples of the drilling

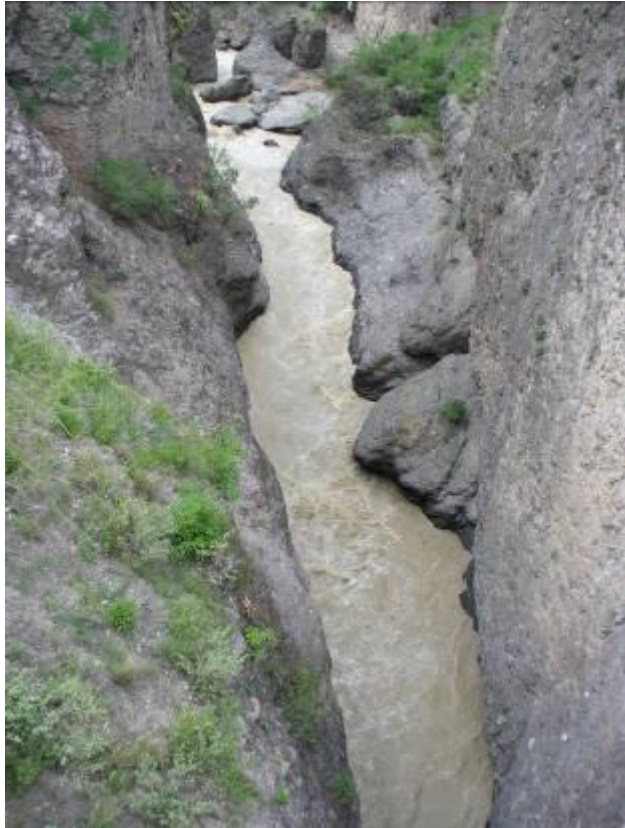
Conglomerate

- The conglomerate, when fresh or slightly weathered, presents good conditions for foundation

- Vertical formation of conglomerate

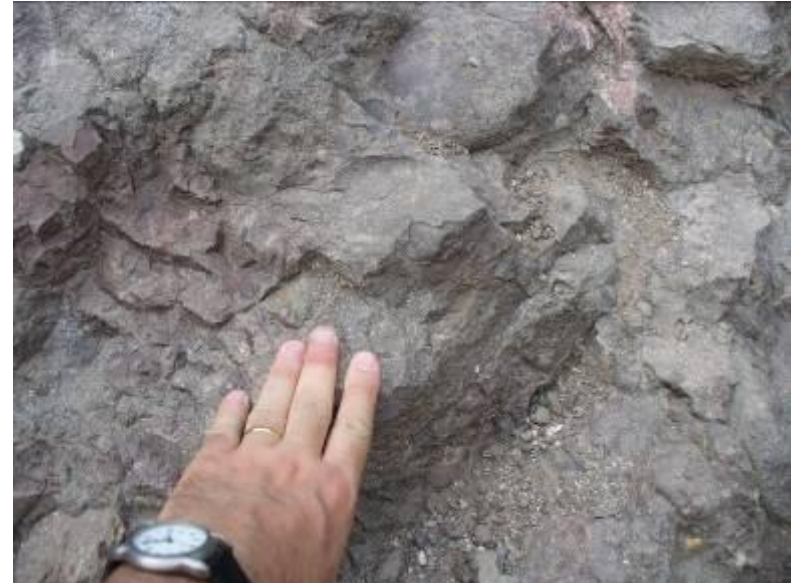
- Close view to the structure of the sedimentary conglomerate
