Due-Diligence of a Small Hydropower Plant

Case Study Peru HPP

Training Workshop “EBRD: Financing Small Hydropower Plants in Ukraine”

Kiev, 05.10.2011

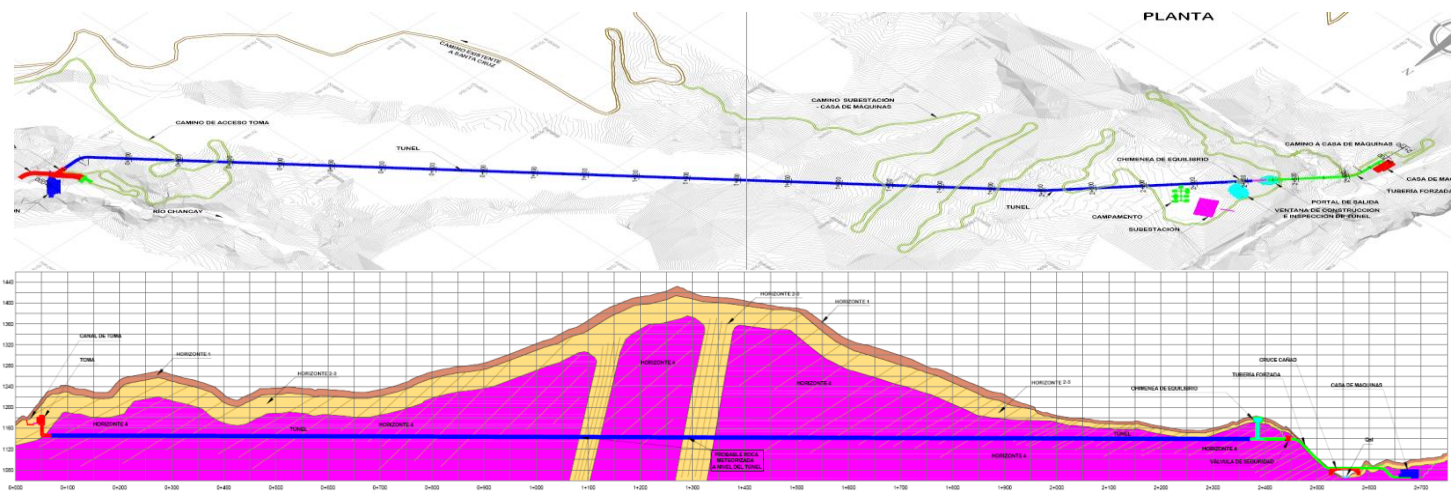
- The zone presents an overburden of soil, followed by a thick strata of sedimentary conglomerate cemented by siliceous material. Approximately at the river level, outcrops of very hard and competent rock can be found. The only exception to the above defined strata is the area of the power house which is formed by weak and erodible material until the rock base at river level.

- **The accurate geological information, in regard to elevation and thickness of the different strata, needs to be processed and is not yet available. The report of the present campaign is expected to be issued within two to three weeks. (End of April 2010)**

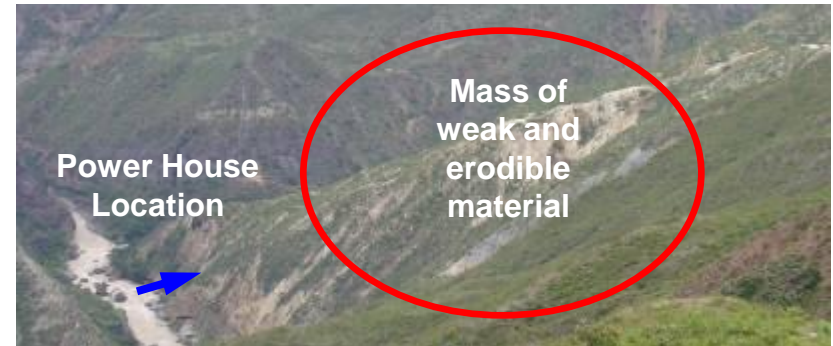
- The necessary excavation to reach the foundation for the power house, will pose even more strain on that soil mass, making the entire power house location very vulnerable to landslides.

- Deep water ways, eroded in the weak material
- The location selected for the Power House in the Basic design, in light of the findings of the drilling campaign is very vulnerable to landslides during the rainy season, making the location practically unfeasible.

- An alternative location needs to be studied. At first sight, the location at the foot of the penstock hill seems to be the most convenient one.
- **The Consultant** has already identified the problem, has carried out drillings at the foot of the slope and is evaluating alternatives to overcome the diverse geological problems.

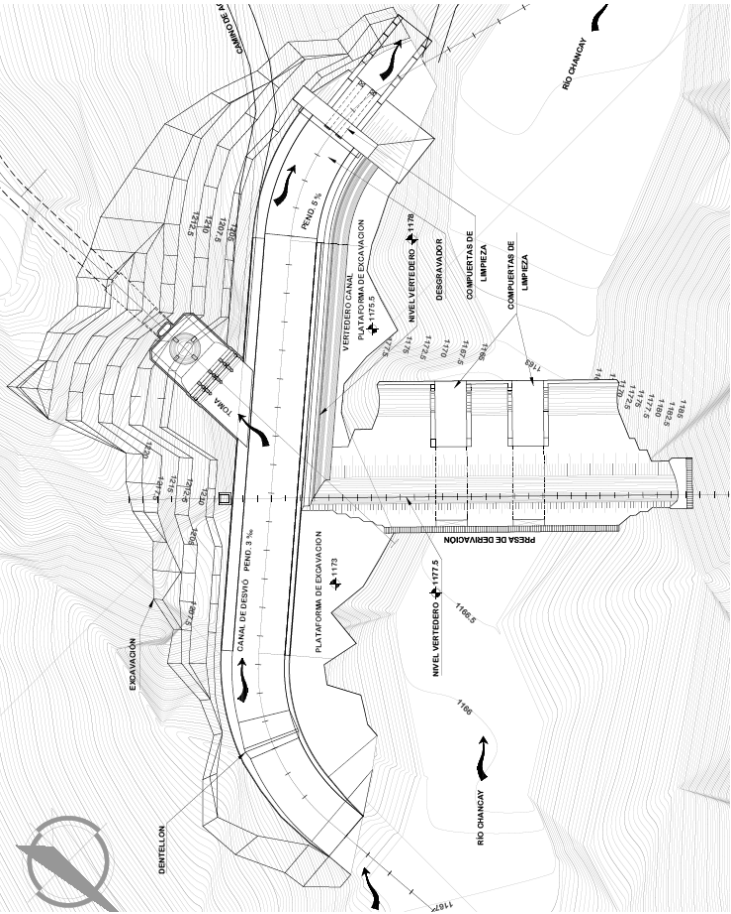
Plan View of Dam, Channel and Intake

- Hydrology was checked and approved.
- The design of the intake with attached desander will most probably not work. Modifications would be necessary, e.g. shifting the location of the dam further upstream.

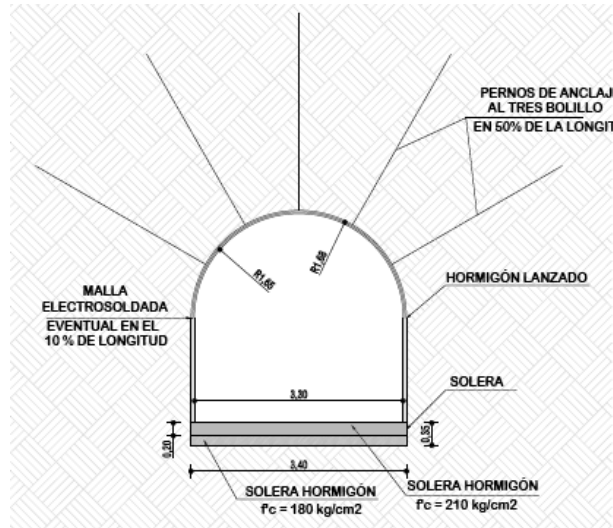
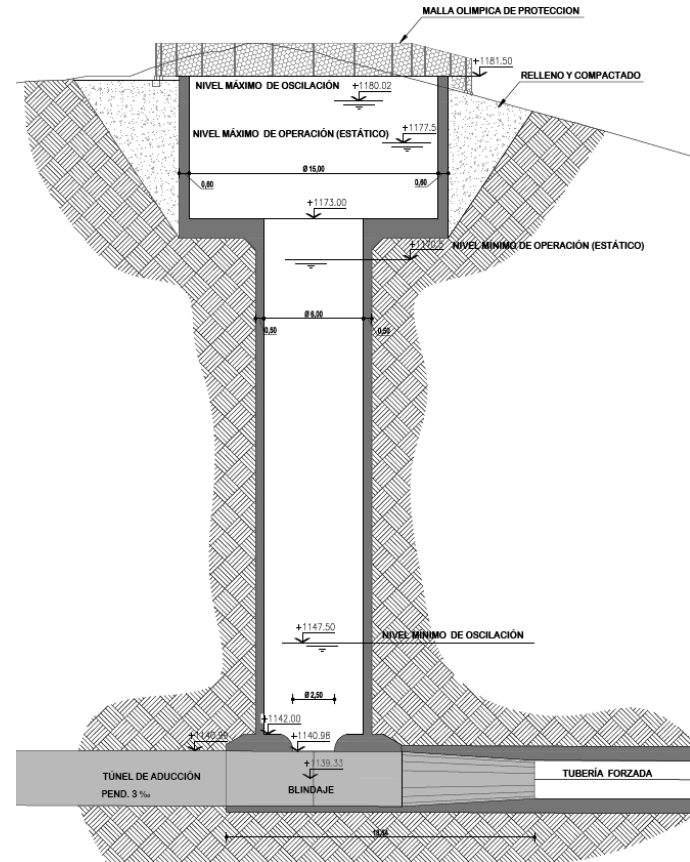
Tunnel Section and Surge Tank

- Right upstream of the surge tank, the topography shows a depression that leaves the tunnel with little covering (approx. 15 m). The boreholes in that zone show presence in depth of highly weathered soil-like material.

- In geological Classification of Rock no transition between Class II and IV considered. Class III in between necessary, probably leading to higher costs for tunnel excavation.

- Section between surge tank and penstock considered to be Rock Class II. This appears rather unlikely and it is recommended to set up Class III or IV.

- It is recommended to further investigate that area and evaluate modifications to the tunnel design.
- **A Consultant** has already commenced some evaluation of possible alternatives to overcome this problem.
